Manhole Inspection Summary

Manhole # S29KK_053MH

Insp Date: **6/10/07 10:27 AM**

Location Address: **1743 NORTH AVE**

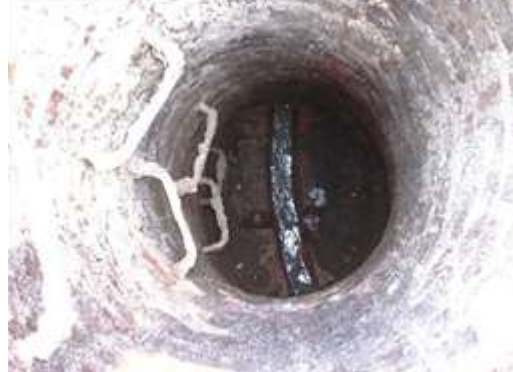
Top View

Corroded steps. Evidence of surcharge - Bench debris.

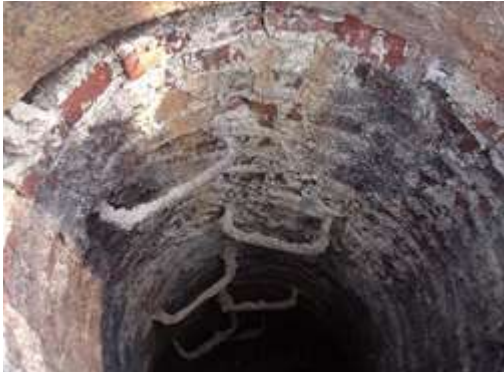
Defect

Frame leaks. Frame offset. Adjustment deterioration, loose brick and infiltration - other side.

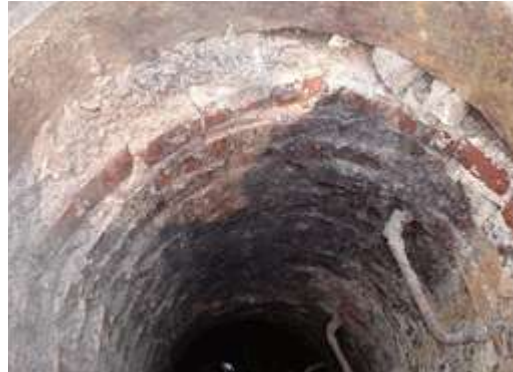
Defect

Frame leaks. Frame offset. Adjustment deterioration, loose brick and infiltration.
